RPI Field Service Smart Kit® (RPI Part #SCK028)

A Guide to Maintaining The SciCan STAT/M® Cassette Autoclave

For use with these models only: STATIM 2000, model 101102 (with S/N ending in "A") STATIM 2000, model 121101 STATIM 5000, model 01-201103

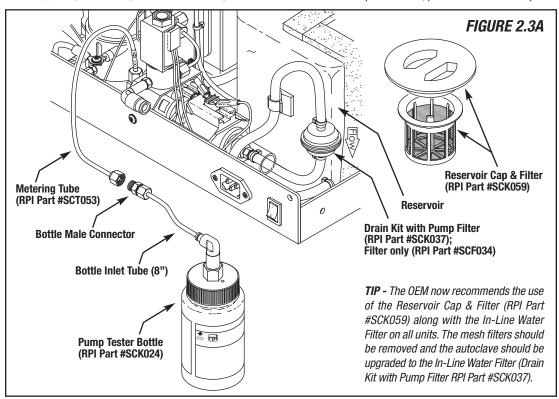
STEP #3 - TEST CYCLE: Before activating the pump for the Test Cycle, have a stopwatch or another timing device available for use during the Test Cycle. Activate the pump and note the amount of time that it takes for the water level in the bottle to reach the MINIMUM FILL LINE.

- If the water level reaches the MINIMUM FILL LINE within 25 seconds, pump testing is complete and no further steps are required.
- If the water level does not reach the MINIMUM FILL LINE within the specified time, proceed to the next step.

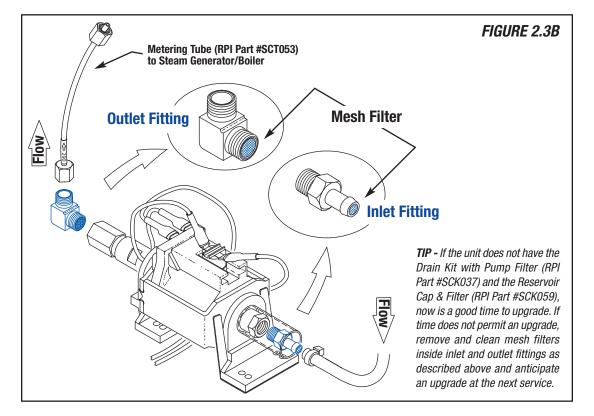
- If the autoclave has been upgraded with Drain Kit with Pump Filter (RPI Part #SCK037), be sure to remove the mesh filter from both the inlet and outlet fittings (if they have not already been removed). The ULKA brand pump does not have the mesh filters. Replace the Water Filter (In-Line) (RPI Part #SCF034). Repeat Step #2 Prime Pump, then if the water level still does not reach the MINIMUM FILL LINE within 25 seconds, replace the pump.
- If the unit does not have the Drain Kit with Pump Filter (RPI Part #SCK037) installed, then clamp off the pump inlet tubing from the reservoir using hemostats or a tubing clamp (Note: It is important to clamp the tubing so that the reservoir does not drain). Disconnect the metering tube from the pump. Remove the filtered elbow outlet fitting and the filtered barb inlet fitting from the pump. (Caution: Use a wrench on the pump body while

removing filtered fittings). Clean the mesh filter of both the inlet and the outlet fittings by placing the fittings under running water, then blow both ends out with an air hose. Reinstall the filtered fittings using Teflon® tape (see Figure 2.3B). Be sure to prime the pump in order to purge trapped air before running a complete cycle. If the water level still does not reach the MINIMUM FILL LINE within 25 seconds, replace the pump (see *Tip* in Figure 2.3B). For additional information regarding the pump see page 43 - Figure 9.6.

PART	RPI PART #	STERILIZER PM TIP
Water Filter (In-Line) SCF034 or Pump Mesh Filters		Debris is the #1 reason for pump failure, so before replacing this filter, be sure to check the reservoir for dirt and debris. Inspect and clean or replace the Reservoir Cap & Filter (RPI Part #SCK059). Drain, clean and flush the reser- voir. Refill reservoir with distilled water after filter replacement.
		If your autoclave comes equipped with an In-Line Water Filter, cut the cable ties and remove the old filter. Note the flow arrow direction on the filter body (flow direction is from the reservoir to the pump). Install the new filter using the new cable ties included. Be sure to prime the pump in order to purge trapped air before running a complete cycle. If your machine does not have an In-Line Water Filter, then be sure to clean the pump mesh filters (located inside the pump's input and output port fittings). See page 6 and 7 - Figure 2.3 A and B.

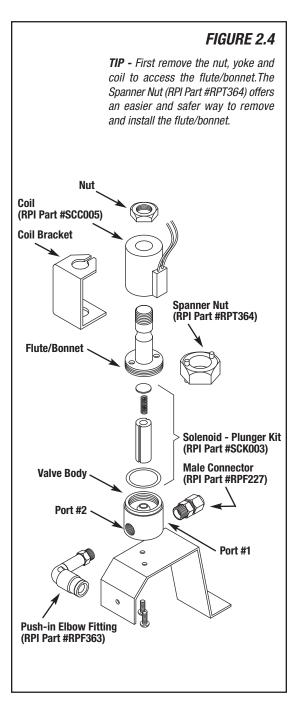
When removing the solenoid flute/bonnet, it is suggested by the OEM to use a pair of pliers on the welded area of the flute/bonnet. If done incorrectly, the pliers could collapse the hollow area of the flute/bonnet, thus preventing the plunger from moving freely.

STEP #3 - Using a wrench on the Spanner Nut; loosen the flute/bonnet to access the internal parts of the solenoid valve.

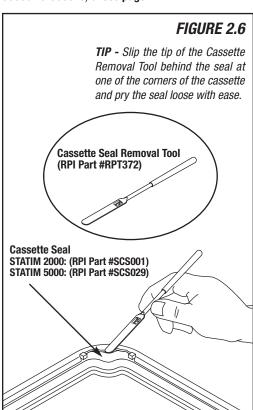
The Cassette Seal Removal Tool was designed to help remove the cassette seal for either maintenance or replacement without scratching the cassette lid or damaging the seal.

Slip the tip of the tool behind the seal at one of the corners of the cassette and pry the seal loose (see Figure 2.6). Once the first corner is free, take hold of the cassette seal and pull down and out in order to remove it from the cassette groove. The cassette seal and groove can now be inspected and cleaned. For additional information and tips, see "Installation and Monthly Maintenance Guide" that is supplied with RPI's Cassette Seals (RPI Part #'s SCS001 & SCS029) or see page 22.

- Remove and clean cassette seal and groove. Reinstall cassette seal. Run a cycle and reinspect for leakage. See page 10, Figure 2.6.
- Confirm that the cassette seal port holes are not damaged and that they are properly aligned within the cassette groove.
- Ensure that there is no debris or residue on outer edges of cassette tray.

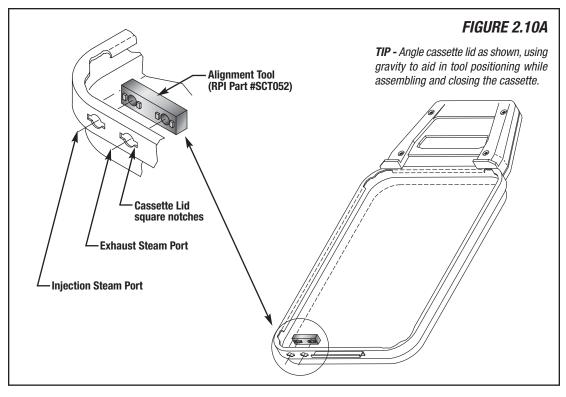
STEP #3 - The cassette is now ready to be used to align probe bracket steam ports.

STEP #4 - If realigning an existing probe bracket, loosen (DO NOT REMOVE) 4 mounting screws (using 9/64" Hex Balldriver - RPI Part #RPT836) and compression fitting connections to allow repositioning of probe bracket steam ports. STEP #5 - Slowly insert the cassette into the cassette bay (armature). As the cassette approaches the probe bracket (still loosely installed), position bracket assembly up and down and sideways until probe bracket steam ports and cassette engage easily. Once properly inserted, the spring bar should engage and lock the cassette into position. A "click" will be heard and felt. See Figure 2.10B.

- Inspect and clean cassette seal and cassette.
- Confirm that the cassette seal port holes are not damaged and that they are properly aligned within the cassette lid groove.
- Ensure that there is no debris or residue on outer edges of cassette tray.
- Verify that outer edges of cassette tray are straight (not nicked, dented, or damaged).
- Check the integrity of the hinge.
- Inspect and clean steam ports on probe bracket. If you
 observe excess debris that is not easily removed or if the
 steam ports appear to be worn or damaged, remove probe
 bracket for proper evaluation. Replace probe bracket if
 necessary. See pages 12 and 13 Figures 2.10 A and B.

- Verify that outer edges of cassette tray are straight (not nicked, dented, or damaged).
- Check the integrity of the hinge.
- Check the cassette tray and lid for warpage.
 Straighten or replace as necessary.
- Inspect and clean steam ports on probe bracket. If you observe excess debris that is not easily removed, or if the steam ports appear to be worn or damaged, remove probe bracket for proper evaluation. Replace probe bracket if necessary. See page 13, Figure 2.10B.

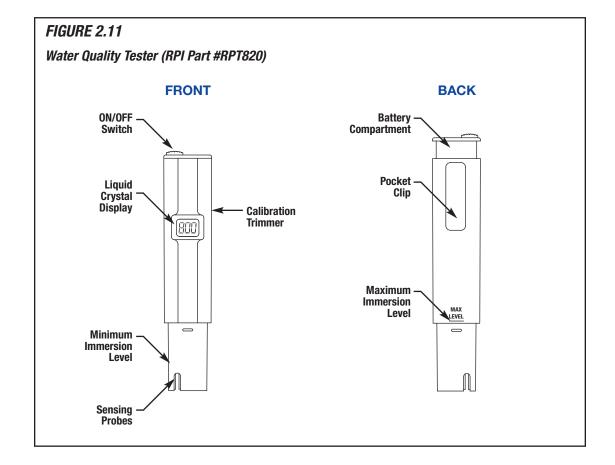
The Water Quality Tester (RPI Part #RPT820) is a meter designed to measure water quality. This meter determines the total amount of dissolved solids (TDS) present in the water being used for sterilization. SciCan states the total dissolved solids (TDS) allowable in the water reservoir to be a maximum of 5 Parts Per Million (ppm) or a conductivity of less than 10 Micro Siemens (μ s/cm). RPI's Water Quality Tester displays its readings in "Parts Per Million" (ppm) and will automatically compensate for temperature variations.

STEP #5 - The reading should be \leq 5 ppm.

BATTERIES - Expected battery life should be approximately 150 hours. Batteries should be replaced when the display will not turn on or fades. The Tester uses (4) 1.5V coin cells (Type LR44 or 357).

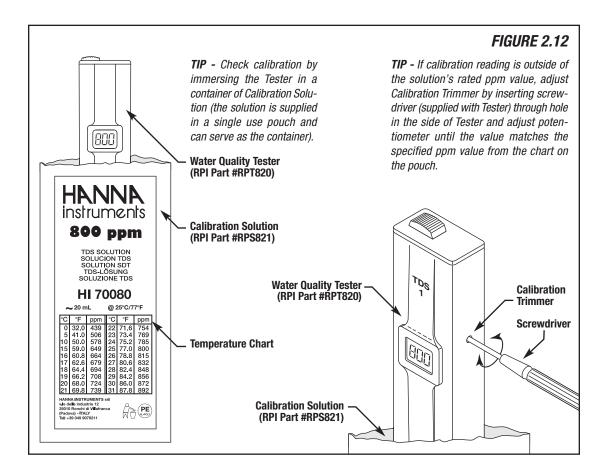
The Calibration Solution is certified traceable to NIST Standard Reference Material Potassium Chloride (7447-40-7) and will provide a reading on the Tester of 800 ppm when tested at room temperature (77°F). Consult temperature chart on Calibration Solution pouch for ppm values vs. temperature condition. SDS sheet available on the RPI website (www.rpiparts.com).

If calibration reading is outside of the solution's rated ppm value, adjust Calibration Trimmer by inserting screwdriver (supplied with Tester) through hole in the side of Tester and adjust potentiometer until the value matches the specified ppm value from the chart on the pouch (see Figure 2.12).

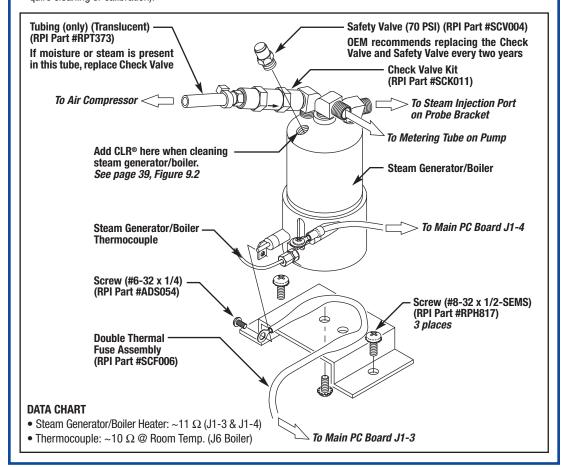
- To check steam generator/boiler heater, disconnect fuse assembly at main PC board J1-3. Measure resistance between the two steam generator/boiler terminals, resistance should read 11 Ω. If not, replace boiler, Reconnect wire at main PC board J1-3.

- Check line voltage at main PC board J1-3 and J1-4 during warm up cycle. If reading is correct, verify voltage at steam generator/boiler terminals.
- Steam generator/boiler thermocouple should read \sim 10 Ω at main PC board screw terminals (J6 Boiler).

- Check thermal fuse for continuity. Replace if necessary
 Thermal Fuse (RPI Part #SCF006) see page 38,
 Figure 9.1 Steam Generator/Boiler.
- Large steam leak is present.
- Over-loaded cassette tray.
- Clean and lubricate cassette seal see page 10, 2.7 Liquid Soap (RPI Part #RPS287). Replace the Cassette Seal if necessary (RPI Part #SCS001 fits model 2000) or (RPI Part #SCS029 fits model 5000).
- Inspect and clean steam ports on probe bracket.
- Check pump for proper operation see page 6, 2.3 -Pump Tester Bottle (RPI Part #SCK024).
- Check steam generator/boiler see page 38, Figure
 9.1 Steam Generator/Boiler.

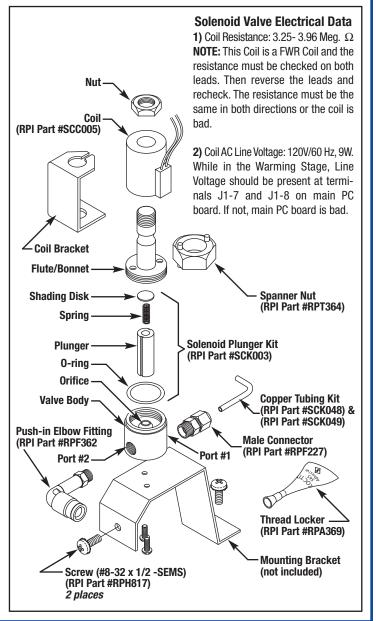
- Avoid crushing the flute/bonnet (which would prevent the plunger from moving up and down freely) by using a Spanner Nut (RPI Part #RPT364) or Spanner Wrench (RPI Part #RPT501).
- Inspect and clean plunger rubber seat, replace if necessary. Uneven wear could indicate a problem.
- Lubricate the plunger (metal body only) with a drop of 3-IN-ONE® oil.
 This can also help reduce valve noise.
- Inspect and clean valve body orifice and ports, looking for damage and debris.
- Check that the coil has been reinstalled in the proper orientation.

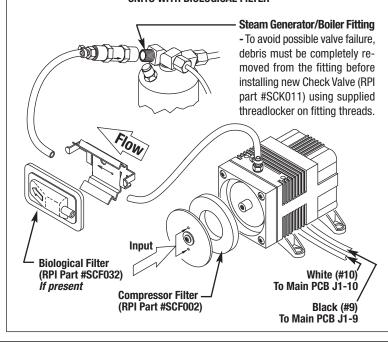
FIGURE 9.7 - AIR COMPRESSOR

The OEM recommends replacing the compressor filters every 6 months or every 500 cycles (whichever comes first).

- To avoid possible valve failure, debris must be completely removed from the fitting before installing new Check Valve (RPI part #SCK011) using supplied threadlocker on fitting threads.

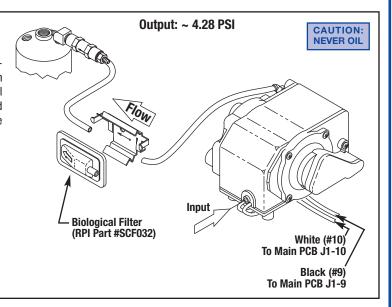
The THOMAS Pump draws unfiltered air into sterilizer. Air is then pushed through the Biological Filter (RPI Part #SCF032) and through the check valve into the steam generator/boiler

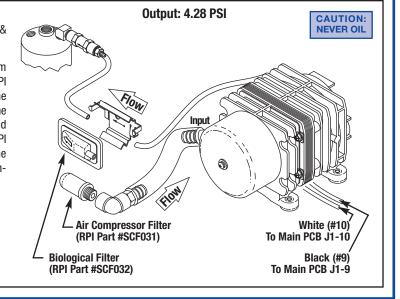
MEDO PUMP

The MEDO Pump draws air from the Air Compressor Filter (RPI Part #SCF031) mounted to the outside of the rear chassis of the sterilizer. Air is then pushed through the Biological Filter (RPI Part #SCF032) and through the check valve into the steam generator/boiler.
